# Labor Shortage Solution — Specifying a Factory-Made Roofing Membrane

Prefabricated membranes and custom prefabricated accessories increase a roof's quality and durability

Sponsored by Duro-Last | By Kathy Price-Robinson

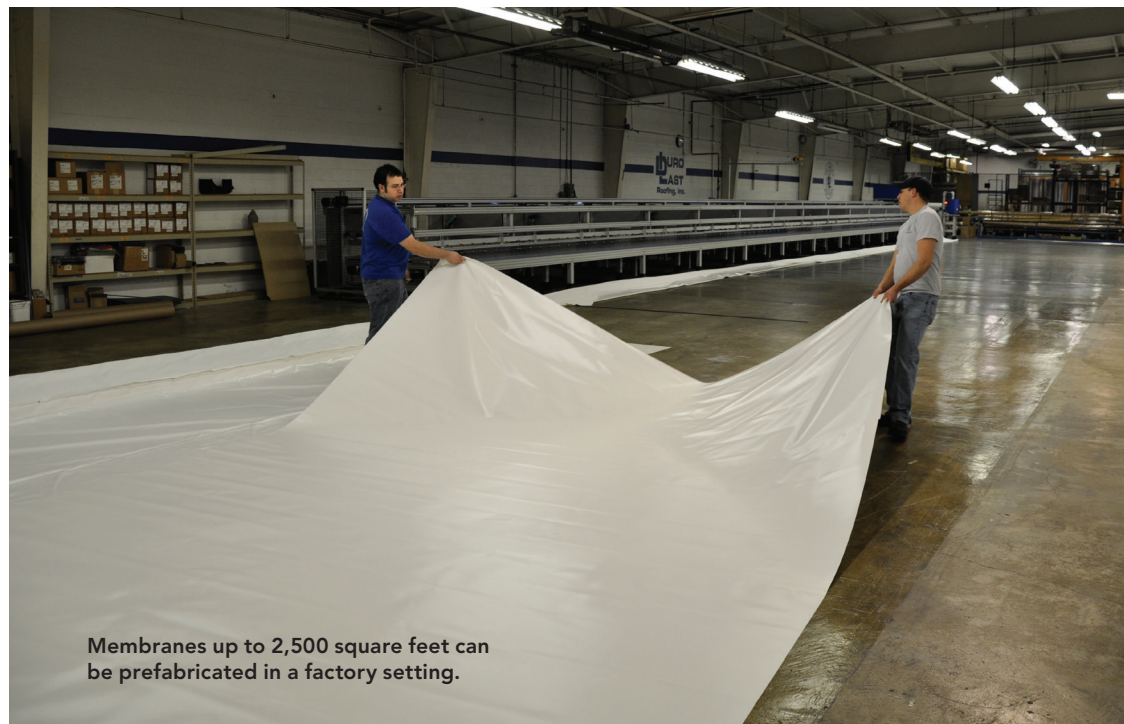
Membranes up to 2,500 square feet can be prefabricated in a factory setting.

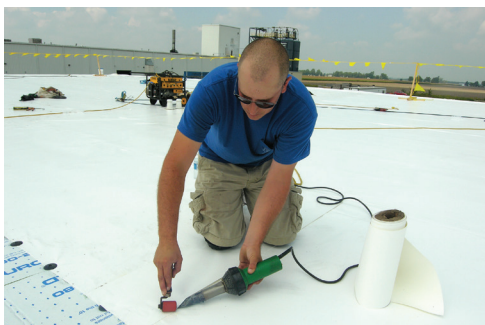
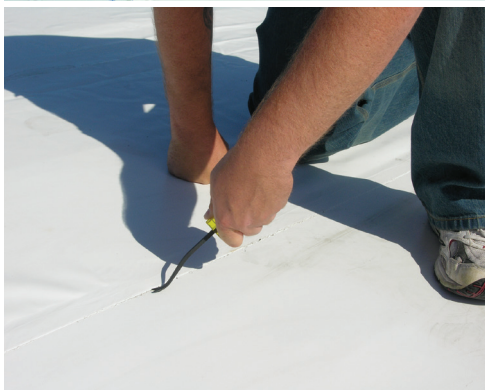
**While up to 85% of the seam welding is done in the factory, the remainder is done on-site with an automatic welding machine, or a hand-held welder, and a silicone roller.**

All field-welded seams must be inspected with a tack claw or similar tool (cotter key extractor), and all deficiencies repaired prior to inspection for warranty purposes.

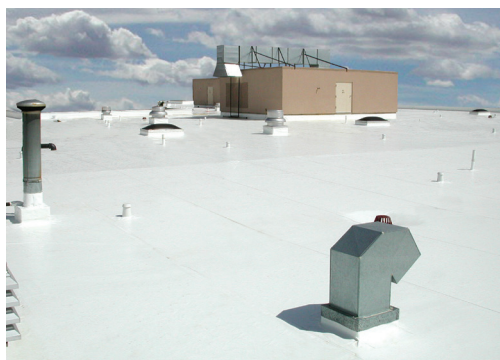
**Prefabricated flashings and accessories help ensure a leak-free finished product with less labor time on the roof.**

To save on labor demands on the roof, and to ensure quality control, prefabricated accessories are custom designed to fit each penetration. These include: pipes, drains, curbs, pitch pans, and expansion joints. For roofing systems that are covered under a thorough warranty, prefabricated flashings are often required. Examples are:

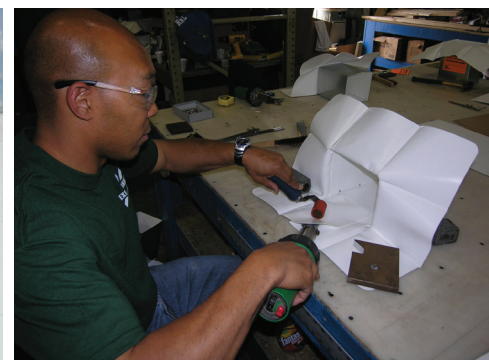
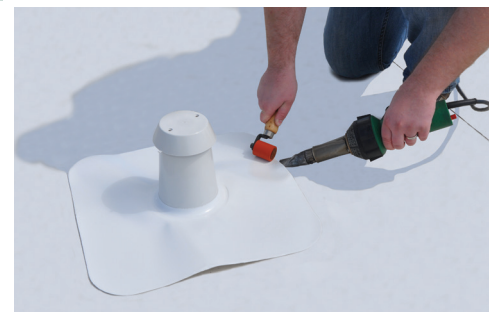
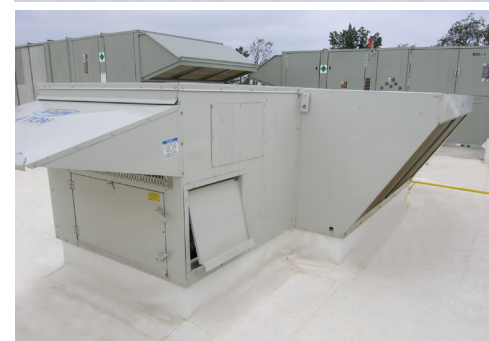
**A custom prefabricated flashing is made inside a factory-controlled setting.**

Prefabricated curb flashings are custom made to fit the units and features of each roof. The one-piece design eliminates the risk of several pieces cut for field fabrication and the potential

for installation and sealing errors from piece-to-piece.

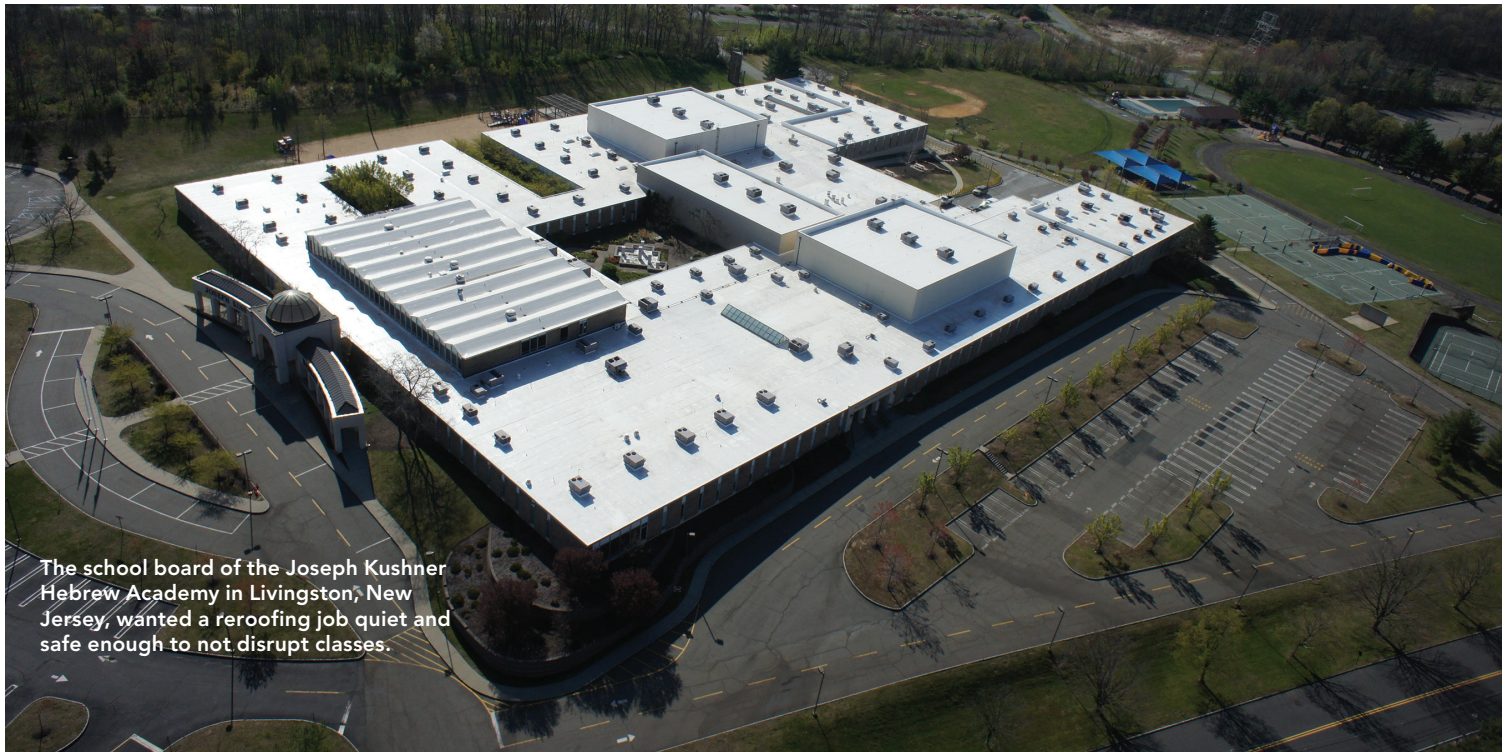
The school board of the Joseph Kushner Hebrew Academy in Livingston, New Jersey, wanted a reroofing job quiet and safe enough to not disrupt classes.

Prefabrication was another advantage of the roofing system selected. The membrane was prefabricated into 22-foot wide rolls, reducing

the application time and on-site welding.

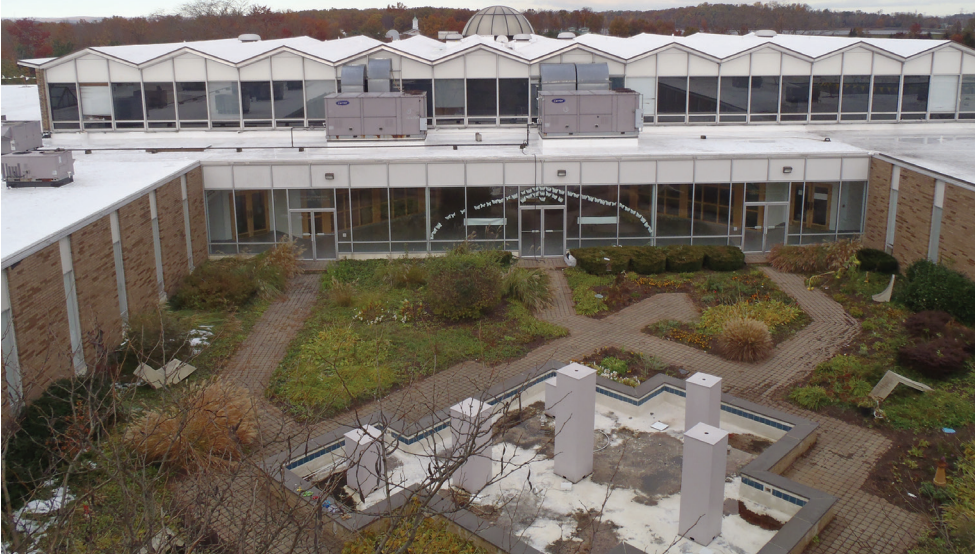
The reroofing job required penetrations for about 400 penetrations, including 126 HVAC units, all on five different roof levels.

The flashings – made of membrane material that connects horizontal and vertical roof surfaces on rooftop protrusions such as curbs and stacks – are prefabricated in the manufacturer's plant, and then delivered to the job site. Had the flashings not been prefabricated, workers would have had to manufacture them on top of the roof, during installation, which could increase the risk of worker error and thus increase the chance of roofing failure.
