CLEMENT ELEMENTARY SCHOOL

Contractor: B&M Roofing | Location: Autryville, North Carolina

Square Feet: 15,000 membrane / 52,000 standing seam

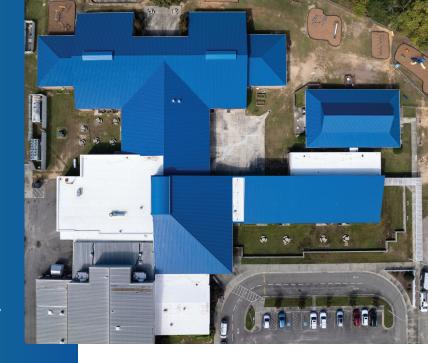
First, B&M Roofing applied to the deck EXCEPTIONAL HT Underlayment, a high-temperature, self-adhering underlayment designed to protect against moisture and high-heat conditions, before installing the EM LokSeam® panels. While some panels were shipped in by truck, many of the panels were roll-formed on-site and crane lifted to the roof because of their length, ensuring a custom fit and preventing the need for mid-panel seams.
